Laser All-Ceramic Crown Removal—A Laboratory Proof-of-Principle Study—Phase 2 Crown Debonding Time

Peter Rechmann, DDS PhD,* Natalie C.H. Buu, DMD, Beate M.T. Rechmann, and Frederick C. Finzen, DDS
 School of Dentistry, Department of Preventive and Restorative Dental Sciences, University of California at San Francisco, 707 Parnassus Avenue, San Francisco, California 94143

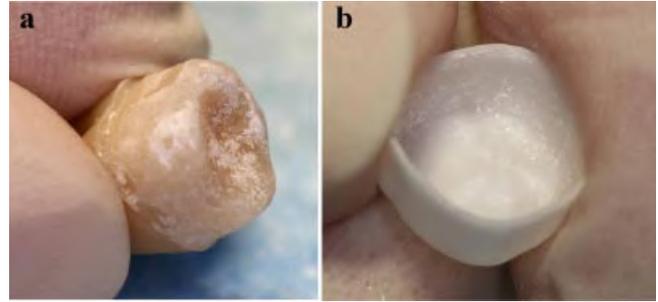
Fig. 1. Zirconia coping with 0.5 mm thickness; (a) Tooth surface immediately after laser debonding of the E.max ZirCAD coping. The cement appears whitish and sticks mainly to the tooth surface; (b) Inside of the ZirCAD coping appearing almost clean.

Zirconia copings with a wall thickness of 0.5 mm were debonded using a laser pulse energy of 300 mJ for approximately 2 minutes. Zirconia copings with wall thicknesses of 1.0 mm were debonded using energies of 500 mJ per laser pulse in less than 5 minutes per coping. Again, after debonding, the crowns did not show any signs of deterioration and no changes of the underlying dentin were observed. In all cases, the cement appeared deteriorated and was easily “scratched off” from the tooth as well as from the inside of the crown with a dull instrument (Fig. 1a and b).

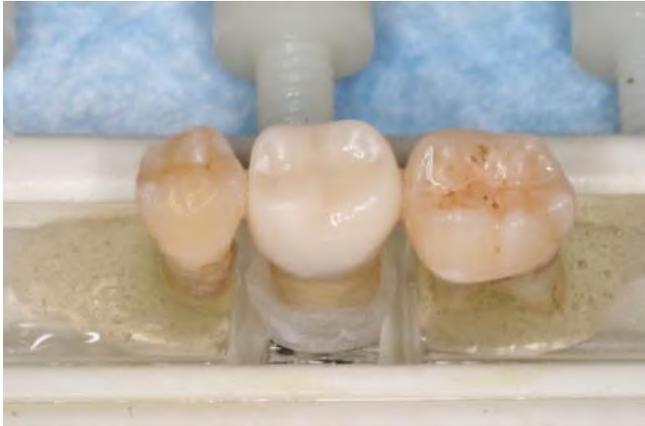
Fig. 2. Mounting sleigh for artificial row of teeth with adjacent teeth in place next to an E.max CAD crown.

Laser debonding of all-ceramic E.max CAD full contour crowns in an artificial row of teeth. All 20 Ivoclar E.max CAD all-ceramic full contour crowns that were cemented on single molars and then positioned in an artificial row of teeth were successfully laser debonded and removed. Figure 2 shows the mounting sleigh with the adjacent teeth in place (one bicuspid and one molar). The fixation screws are partially visible in the back.

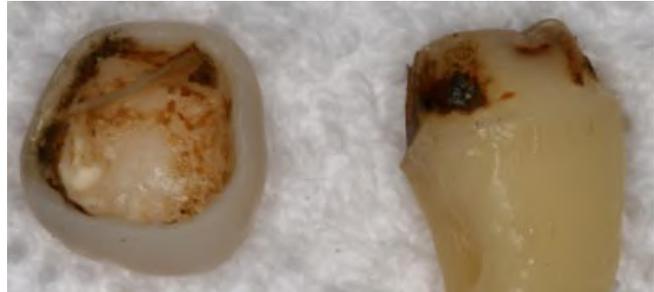
Fig. 3. ZirCAD full contour crown after laser debonding and removal. The pictures show the tooth from the mesial contact point side; No darkening of the cement at the contact points, slight darkening at the cement crown interface.

Laser debonding of all-ceramic ZirCAD full contour crowns (regular margins) in an artificial row of teeth. The average thicknesses of the full contour ZirCAD crowns (with regular cervical margins) was 1.89 ± 0.18 mm for occlusal, 1.6 ± 0.08 mm for buccal, 1.55 ± 0.05 mm for lingual, and 1.57 ± 0.07 mm for mesial and distal surfaces (average \pm SD). All 10 Ivoclar ZirCAD full contour crowns cemented on molars and then positioned in an artificial row of teeth were successfully laser debonded and removed. All ZirCAD crowns were removed in one piece and no crowns fractured during the debonding process. No changes in the underlying dentin were observed. Figure 3 shows a ZirCAD full contour crown after removal. The contact points received less laser energy and the cement is deteriorated, while the other areas received more energy and show slightly carbonized cement at the cement/crown interface.
