Removal of 11 Laminate Veneers with Er-Yag Laser

Case Report

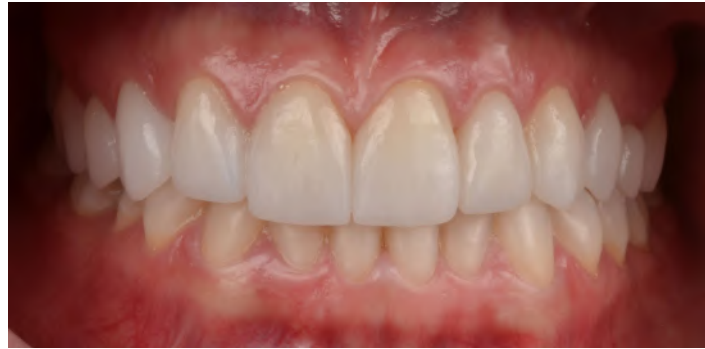
The patient had 11 previously cemented laminated ceramics, from the upper arc's first molar on the right side to the first molar on the left. The patient presented agenesis of element #12. The veneers consisted of pressed lithium disilicate, colour W1, HT pressing ingots (Rosetta-Hass, Gangwon-do, South Korea) and cemented with self-curing cement (Variolink Esthetic, Ivoclar Vivadent-Schaan, Liechtenstein). The etching was performed with 5%-hydrofluoric acid (CEtching, BM4 - Santa Catarina, Brazil) for 20 s, followed by rinsing with water, decontamination in the ultrasonic cleaner with alcohol at 70% for 5 min and water rinsing. After drying of pieces, silane was applied (Primer Monobond N Universal-Ivoclar Vivadent, Schaan, Liechtenstein), followed by warm air jets for 1 min on each side of the drying device of ceramic laminates. So, a thin layer of a universal adhesive (T-Tric N-Bond Universal - Ivoclar Vivadent, Schaan, Liechtenstein) was applied, followed by air jet. On the tooth, 20 sec 37%-phosphoric acid conditioning was performed (Ultradent - Utah, USA), followed by water/air spray cleaning. After drying with absorbent paper, the universal adhesive was used (Tetric N-Bond Universal-Ivoclar Vivadent, Schaan, Liechtenstein), after light air jet drying. The soft coloured light-curable cement (Variolink Esthetic - Ivoclar Vivadent) was applied on the ceramic laminate, and the set was positioned. After the insertion of all sets and excess cement removal, each of their sides were cured (Valo Cordless, Ultradent -Utah, USA) for 40 s. Photograph 1 shows the eleven laminates prior to removal (**Figure 1**).

Figure 1. The initial photograph of teeth.

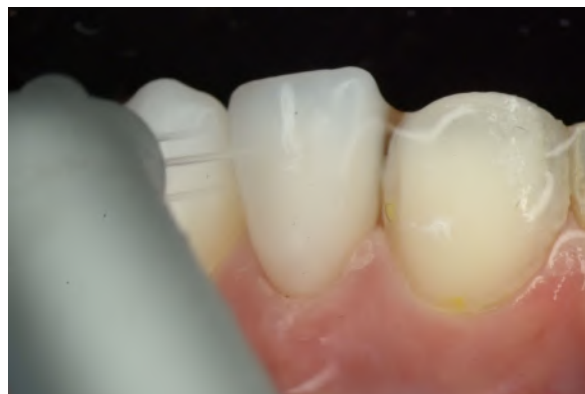
No anaesthesia was required for the debonding procedure. The Er:YAG laser was used, with 2.940 nm wavelength (LiteTouch - Light Instruments, Yokneam Industrial Zone, Israel) set with the following parameters: 20 Hz, 250 mJ, and 5 W, with water/air spray irrigation performed with the laser device existing syringe. The application was initiated with 1 min 30 sec duration, with sinuous movements along the laminate surface and in a perpendicular position along the tooth axis, 5 mm distant from the tooth, followed by a lever movement with the resin spatula. In case the ceramic laminate did not detach, one more minute of laser application was performed and another debonding attempt with the spatula was made. **Figure 2**, shows the moment of removal with the laser in position (**Figure 2**). After the debonding, a verification to check for remaining cement was made, both on the tooth and on the veneer, as well as checking the veneer for cracks and its integrity (**Figure 3**).

Figure 2. Laser Er-Yag debonding laminate veneers.

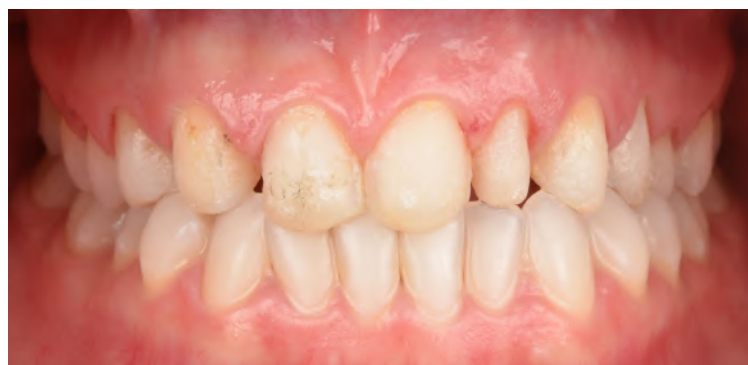
Figure 3. Photograph of the exact moment after removal.

The piece's thickness was verified in three parts (cervical, medium, and incisal) with the use of a thickness gauge. The overall time of each element, integrity, and the presence of cracks were also analysed using a microscope (Zeiss-Oberkochen, Germany) (Table 1).

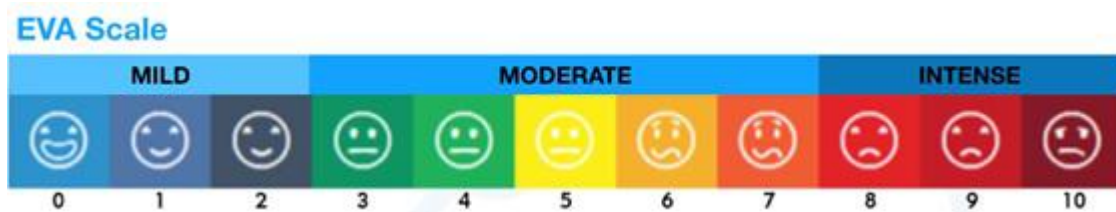
For comfort verification regarding the ceramic laminates debonding with Er:YAG laser, the patient was questioned regarding sensitivity after the debonding of each veneer, and the response was graded as per EVA parameters (Figure 4). The patient reported no sensitivity during the procedure for all elements and total debonding procedure. The answers varied from 1 to 2 for the ceramic laminate veneer debonding with Er:YAG laser.

Figure 4. EVA scale, comfort scale for procedure.

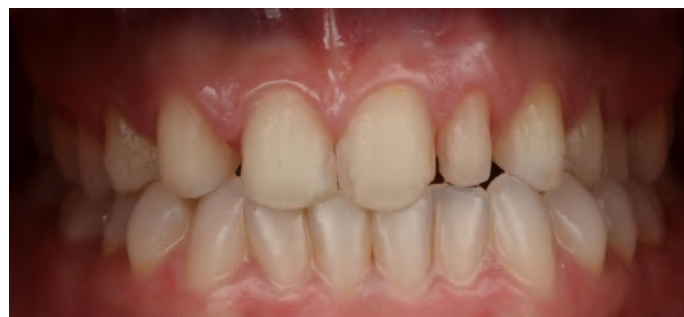
Figure 5. Photograph after reparing the remaining structure.

After the debonding, the elements were prepared with fine and extra-fine diamond tip burs (881F, 881EF, and 859EF - KOMET Besigheim, Germany) contra-angle handpiece 1:5 (Sirona, Salzburg, Austria), finishing and polishing with rubber tip burs (EVE - Keltern, Germany) with 1:1 contra-angle handpiece (Sirona, Salzburg, Austria) (Figures 4 and 5).

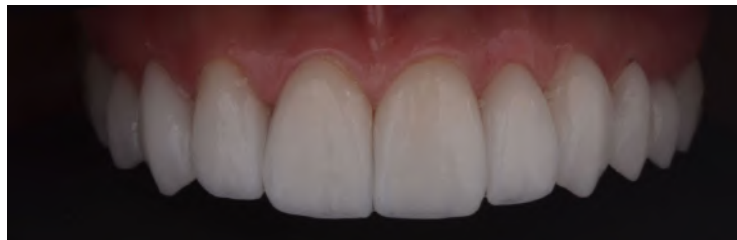
Figure 6. Final Photograph of teeth.

After complete light-curing, the excess cement was removed with the assistance of microscopic magnification (Pro-Ergo Zeiss Oberkochen, Germany) and a scalpel blade (**Figure 6**).
