**LiteTouch Er:YAG Laser Caries Removal and
Gingivoplasty.**

Academy of Laser Dentistry

Advanced Proficiency Clinical Case Studies

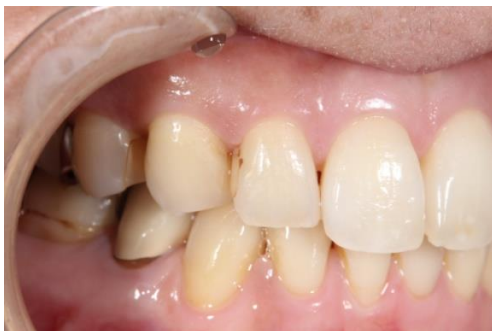
A 27-year-old female presented on December 11, 2017 for restoration of her maxillary right canine and lateral incisors. Clinical examination revealed extensive caries on the mesial and distal aspects of tooth #7 and on the mesial of #6. The decay extended at least to the gingival margin on the mesial aspect of canine.(Figure1 and 2)

Figure 1: Preoperative view

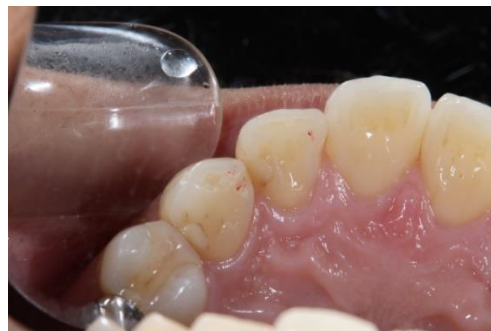
Figure 2: Preoperative palatal view

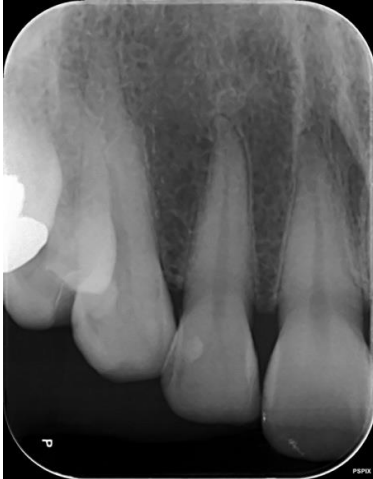
Figure 4: Preoperative radiograph

Periapical X-rays were taken on carious teeth #6, and #7.(Figure 4)

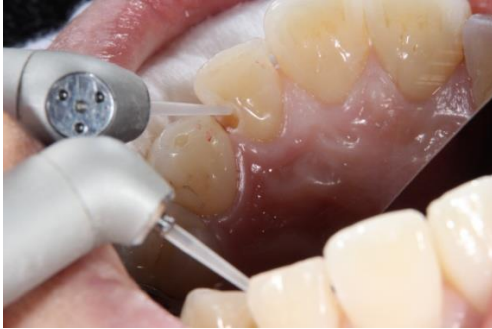
Figure 5: Cavity preparation, palatal view

The laser was first test-fired prior to seating the patient in the dental operatory, to check that the water spray and the laser was working. The laser was used to excavate the decay and then to remove a thin portion of gingival tissue on the internal aspects facing the root surfaces. This facilitated the verification of complete excavation of decay and dry for restoration with composite. Water was cutted for gingivoplasty and soft tissue of interproximal area was shaped for direct bonding restoration. Composite was then placed to complete the restorations. Restorations were accomplished using etch (37% phosphoric acid, American Dental Supply) for 15 secs, followed by application of Universal Adhesive, Scotchbond (3M ESPE), MI LOW FLOW A3 (GC), Light-Cured Nanohybrid Flowable Composite. A curing light (Kerr) was used in accordance with manufacturer's instructions with manual checking to ascertain completion of polymerization.

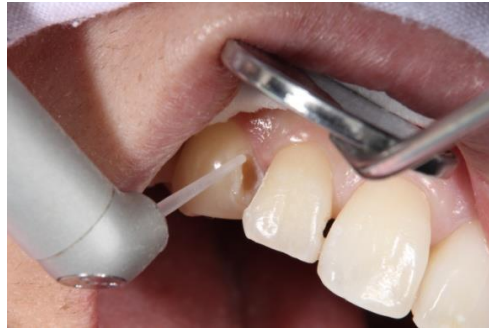
Figure 6: Cavity preparation

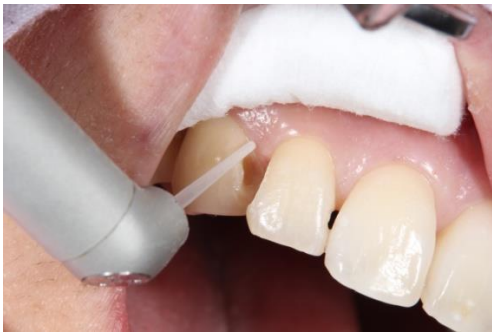
Figure 7: Laser in for sulcular development

1. Wavelength: 2,940 nm
2. Delivery system: Direct Drive Delivery System
3. 800 micron sapphire tip was used with water for the treatment of the caries.
4. Initial settings for caries removal were 300 mJ and 20 Hz for 3 minutes.
5. Afterwards, a lower setting for deep caries removal was used; 120 mJ and 20 Hz for another 3 minutes.
6. Same tip was used for gingivoplasty without water, 50 mJ and 20 Hz, 1 minutes.

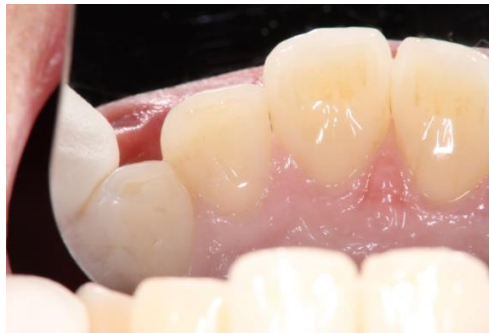
Figure 8: Immediate post-treatment

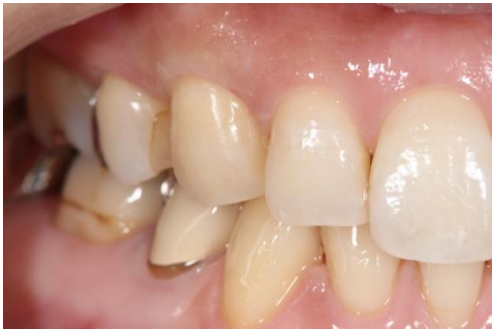
Figure 9: Immediate post-treatment

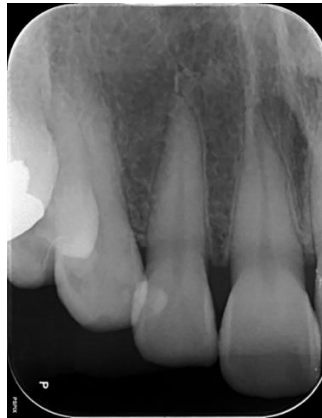
Figure 10: Pretreatment radiograph

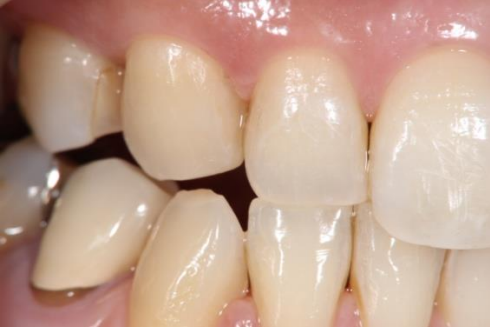
Follow-up assessment was carried out during the 3 months after treatment. Pulp tests proved positive. The patient was pleased with the esthetics and was reminded to maintain optimal oral hygiene.

Figure 12: Three-month postoperative view

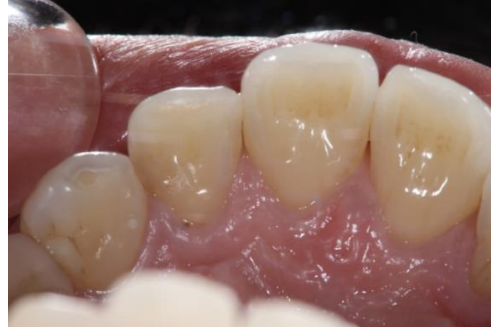
Figure 13: Three-month postoperative view

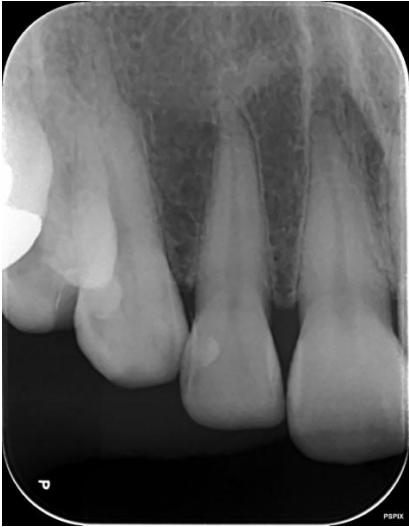
Figure 14: Three-month of periapical radiographs

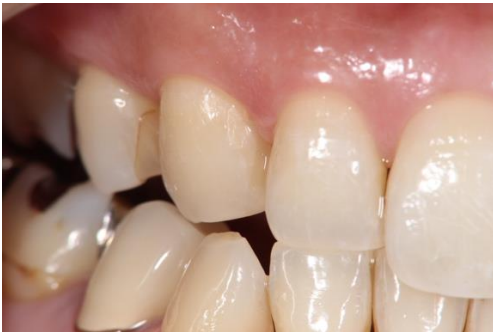
Long-term results were observed to be good with continued 6-months recall visits. All teeth retained vitality and esthetics, and the restorations appeared unchanged from time of placement.

Figure 15: Six-month

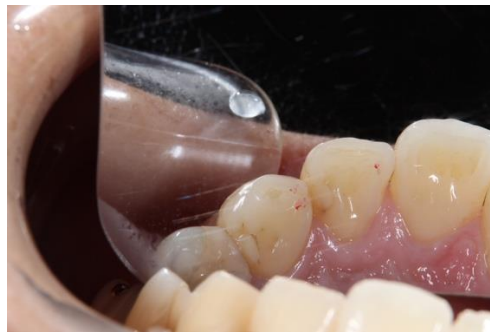
Figure16: Six-month
